Tongass
National
Forest
R10-MB-116

Shelter Cove

Draft Environmental Impact Statement

Volume II: Maps

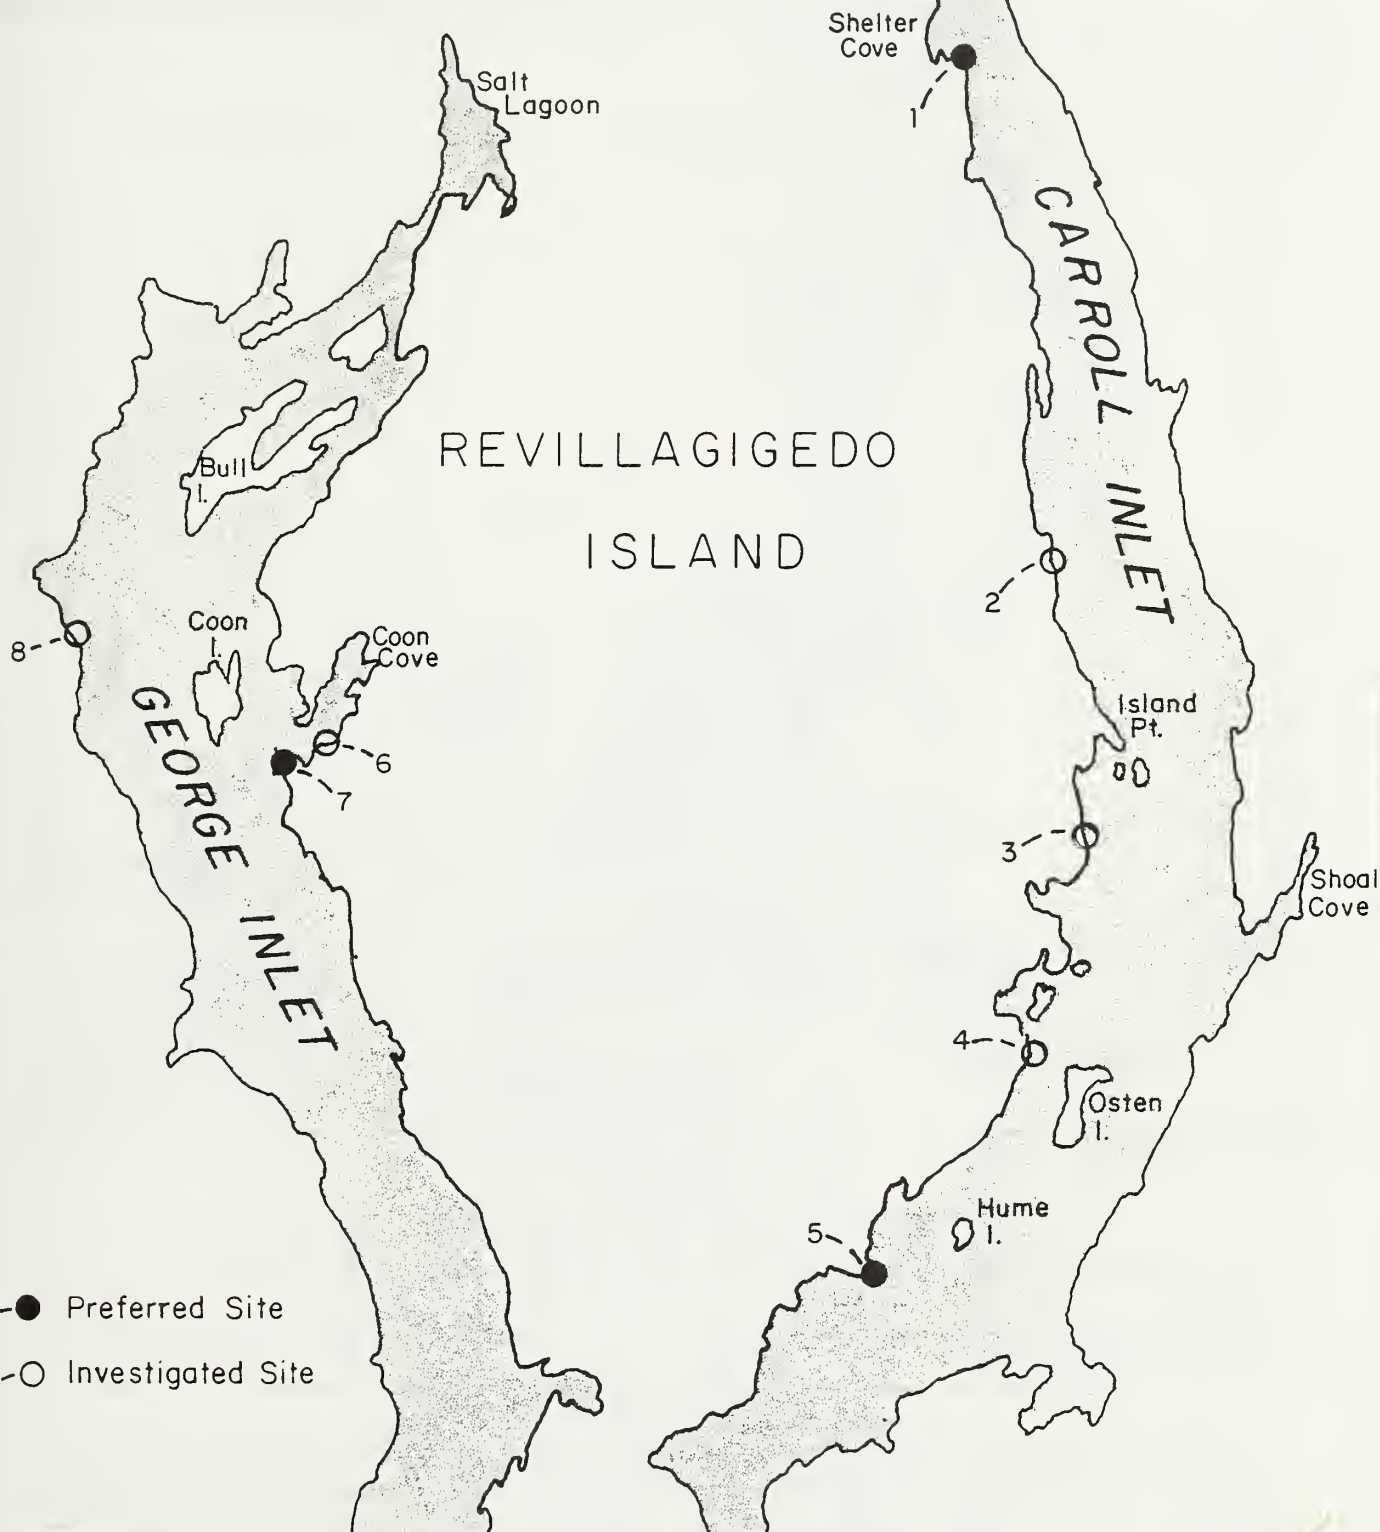
AREA L.T.F. SITES
 GEORGE & CARROLL
 INLETS

The first map indicates all new sites that were considered. Those that were eliminated did not meet pertinent siting guidelines and are indicated on the maps as investigated sites. The preferred sites were investigated and are proposed for use in the various alternatives considered in this document.

- Preferred Site
- Investigated Site

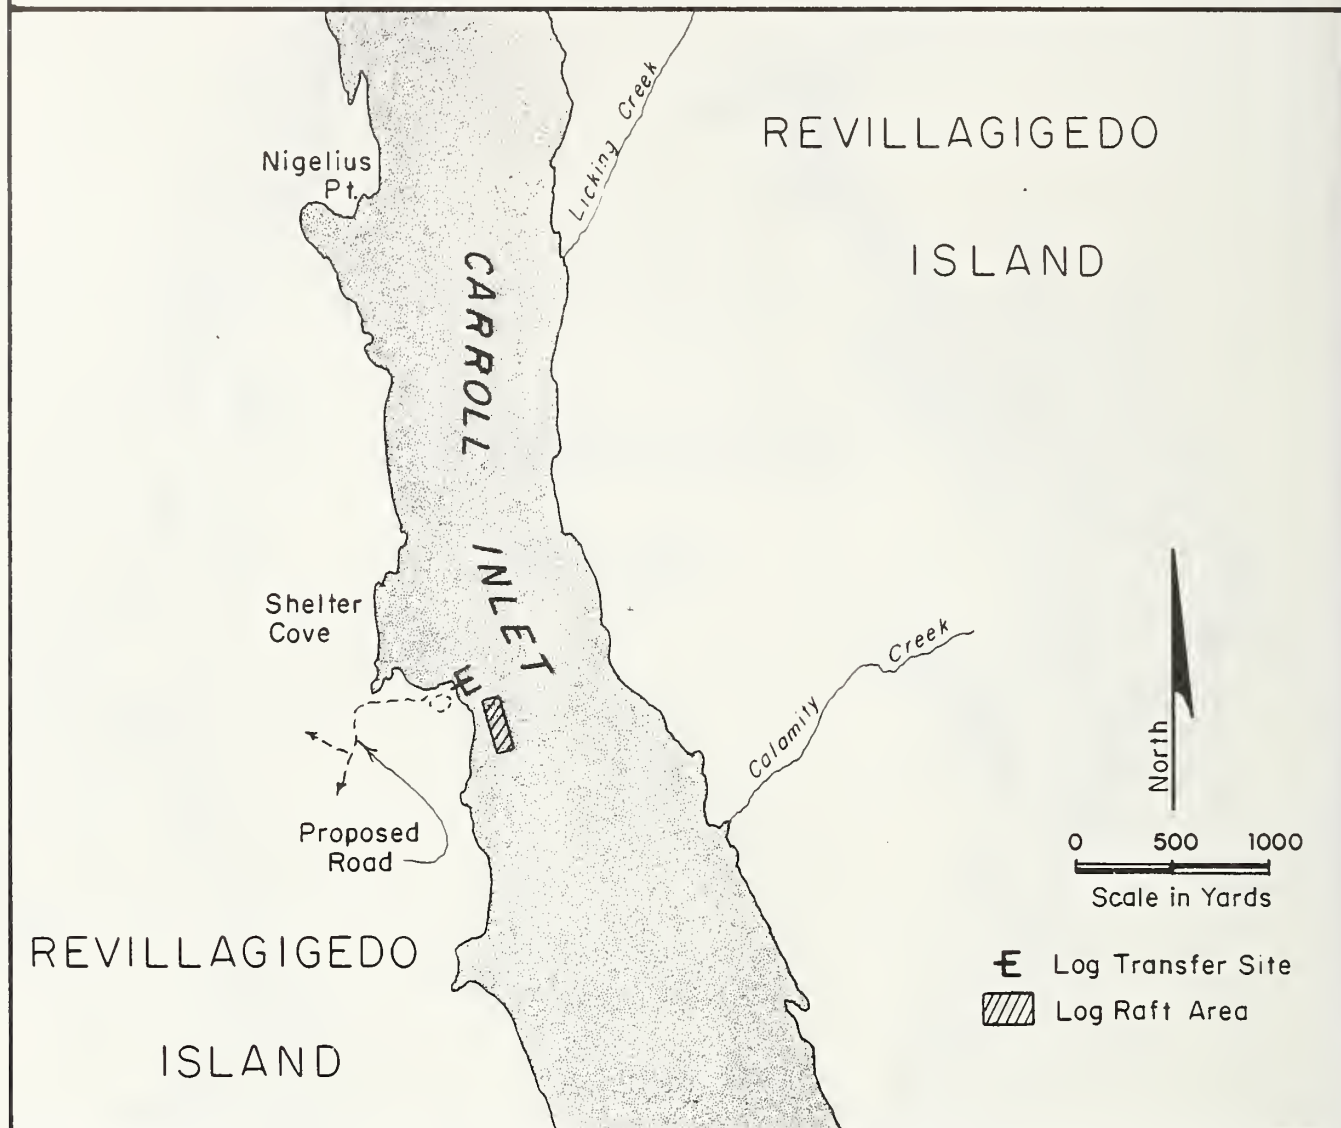
SHELTER COVE PROPOSED L.T.F.

ALTERNATIVE					
	1	2	3	4	5	6
Used		X	X	X	X	X
Reconstruction						
SYSTEM TYPE						
Double A-Frame		X	X	X	X	X
Slide						
Float-Off

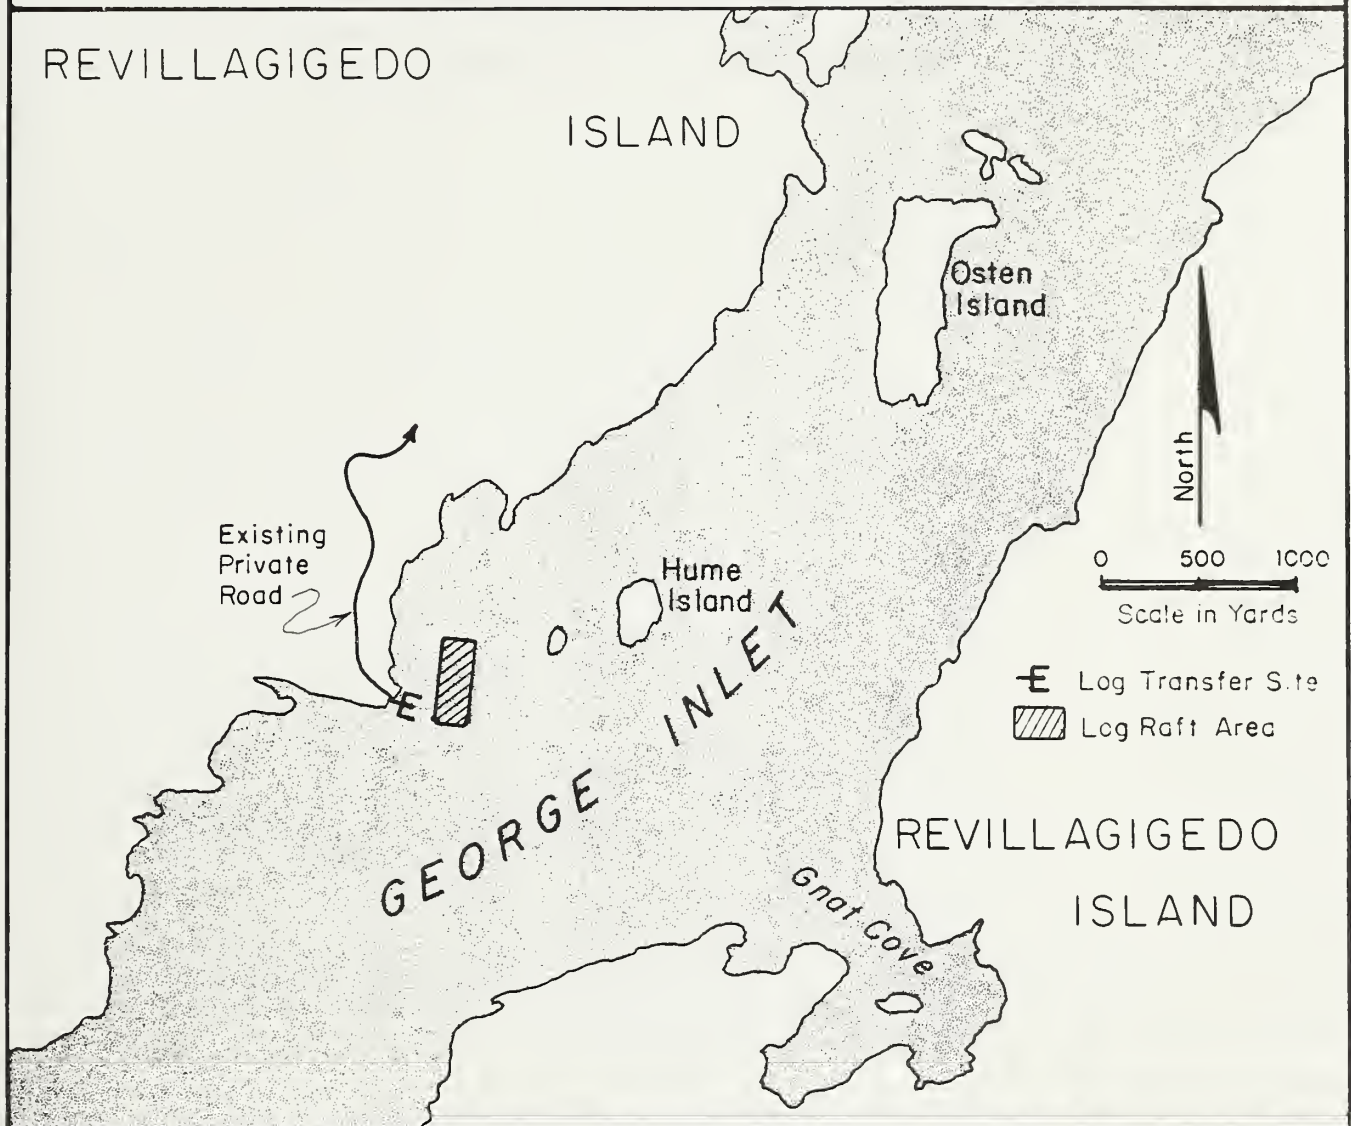
HUME ISLAND EXISTING L.T.F.

ALTERNATIVE					
	1	2	3	4	5	6
Used					X	X
Reconstruction						
SYSTEM TYPE						
Double A-Frame					X	X
Slide						
Float - Off

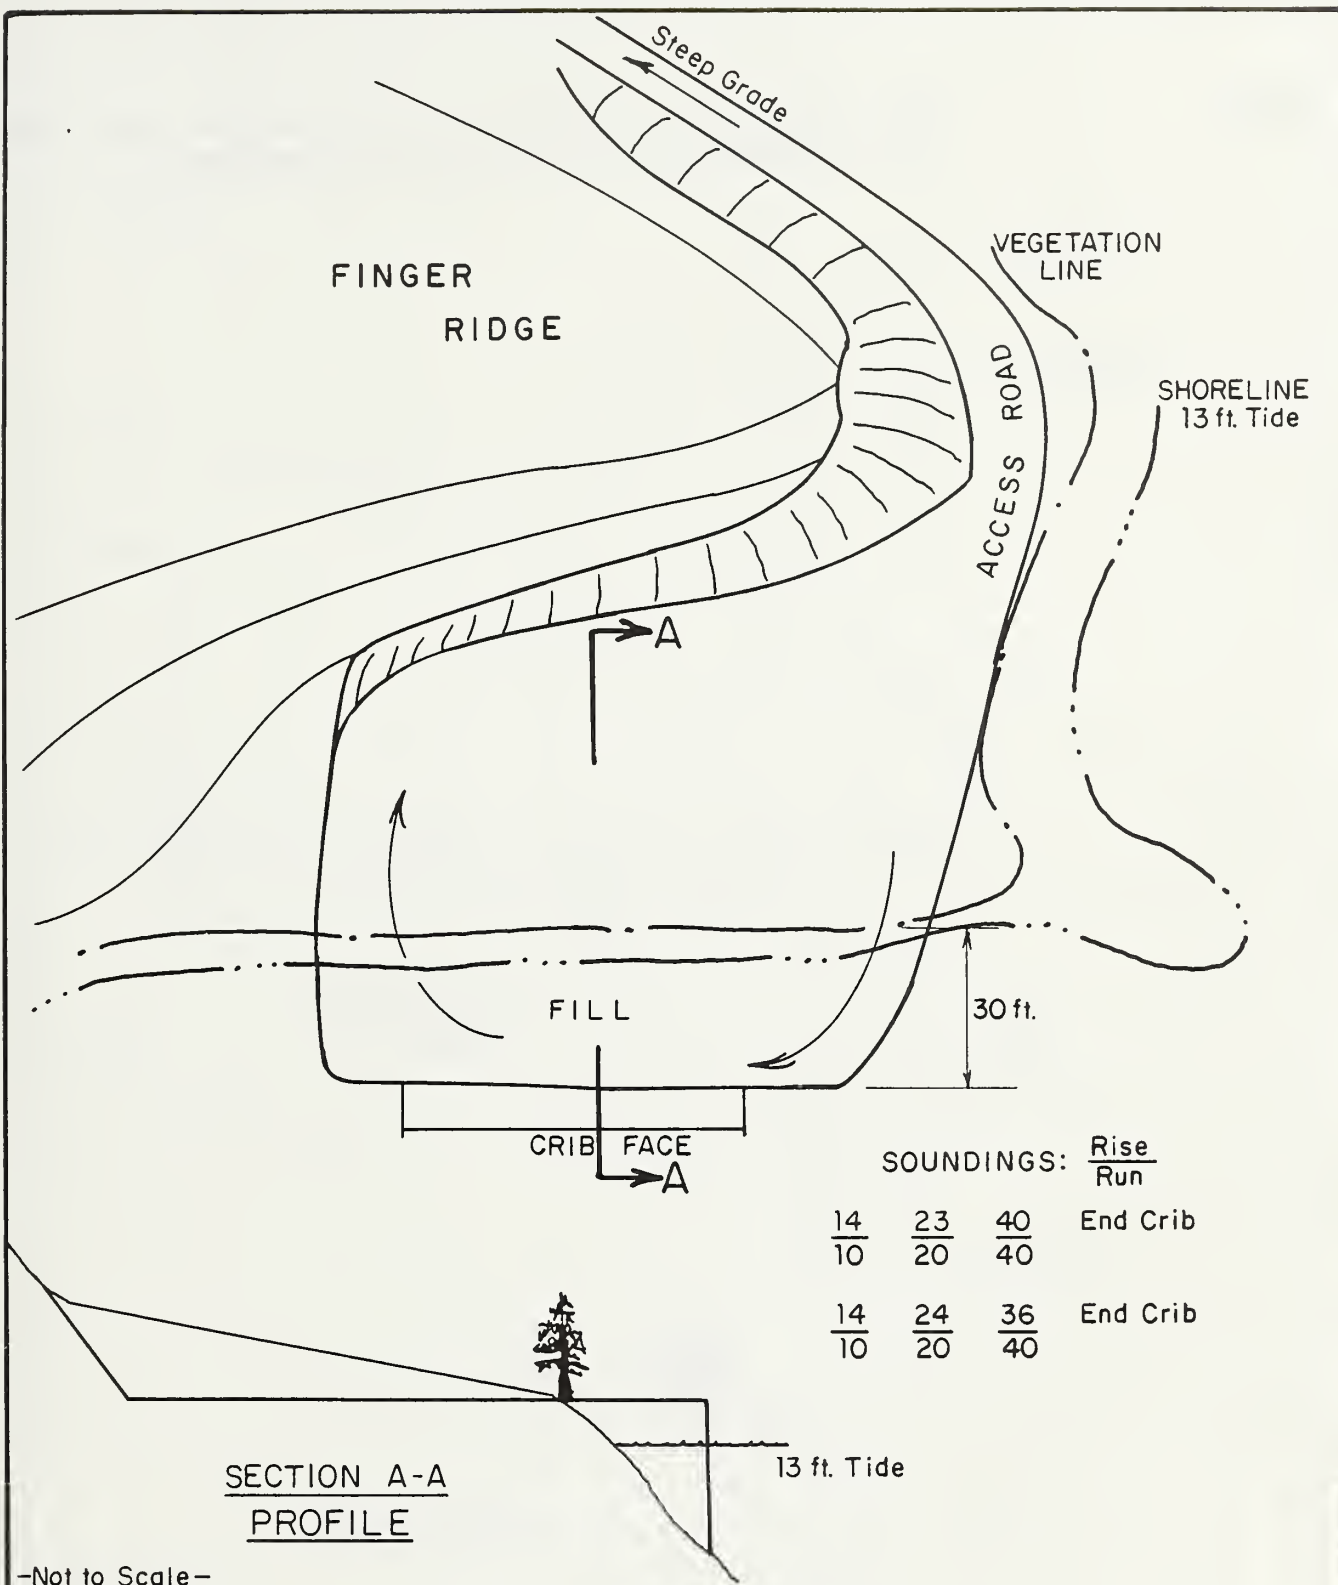
SITE 1 - SHELTER COVE - WEST CARROLL

Site 1 — Shelter Cove

- The site appears to have adequate upland area.
- Favorable for A-frame system.
- Dry sort and storage is not available at the site. Dry sort and storage may possibly be located $\frac{1}{4}$ to $\frac{1}{2}$ mile from site.

- Rock borrow is adjacent to the site.
- Good beachhead adjacent to site for equipment mobilization.
- Site requires moderate fill and rock excavation.

- Access road would be about $\frac{1}{2}$ to $\frac{3}{4}$ mile long.
- Road will contain some minor segments with very steep grades.
- Site is adequate for a drive-through loop road.
- Approach to dump position is suitable.
- Access road will have a very heavy through-cut adjacent to the site. The cut will be about 100' long and 20-30' deep. This can serve as a rock source if it proves adequate.

- The site has adequate water depth.
- According to the navigational charts, Carroll Inlet has very good depth.
- Ample raft and booming area is available at the site.

- The site appears to lie in a favorable area.
- Water depth indicates suitable flushing.
- Eagle Tree Atlas does not indicate the presence of any eagle trees.
- Site is protected from weather.

- The site appears to be adequate and should be considered further. Marine, archaeological, and economic impacts should be evaluated in more detail. Additionally, the area should be surveyed for eagle trees.
